Performance Under Pressure: Structural Insulated Panel (SIP) Walls

IFAS Extension | School of Natural Resources and Environment | Program for Resource Efficient Communities | www.energy.ufl.edu

Universal Model (1-Story)

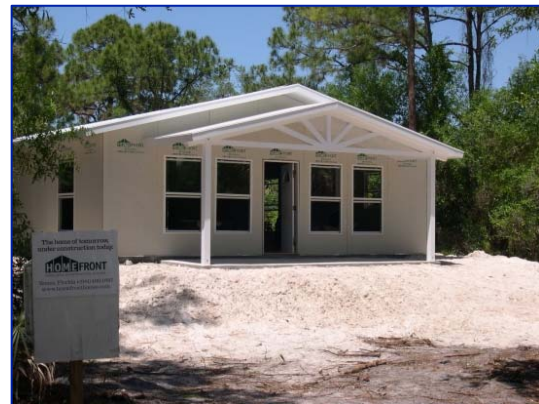
A Home Front, Inc. residence can be dried-in after about 3 days with a shell cost of approximately \$25 per square foot.
(Source: Home Front, Inc.)

- Once the floor slab is completed, Home Front's system can "dry-in" a house within approximately three days using a small crew of about four people. Some SIPs arrive on site with wiring and plumbing chases pre-installed from the factory.

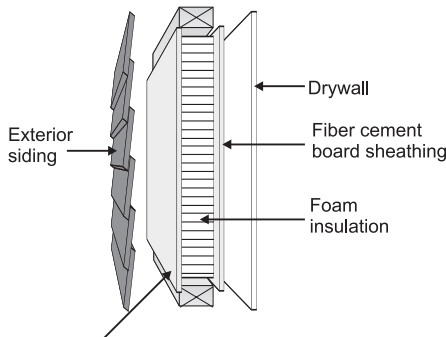
Fiber cement board sheathing

Typically, SIPs have a foam core surrounded by structural sheathing such as fiber cement board.

During testing, the Home Front, Inc. SIP wall system, consisting of 5/16” thick Hardie® cement board sandwiched around a 4” thick core of polystyrene foam, deflected less than 1/8” under an approximately 1,000 lb/ft load. The wall’s breaking strength has tested to be approximately 7,000 pounds.

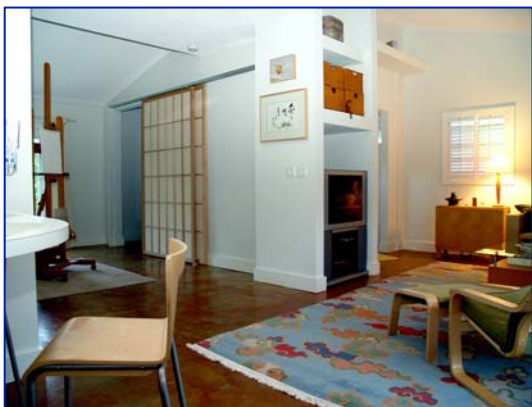
The Home Front, Inc. SIP houses have vaulted ceilings and ductwork inside the conditioned space.

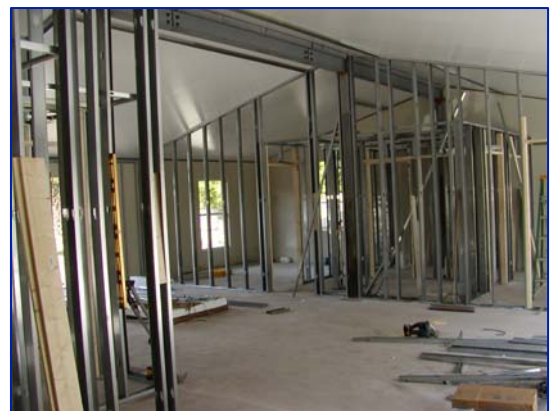
Home Front, Inc. uses a steel moment frame to improve wind resistance and steel studs to increase termite resistance.

Another high performance feature of the Home Front, Inc. system is an internal steel moment frame that stabilizes the SIP structure and adds additional wind resistance capacity. Further innovations in the Home Front, Inc. system include a proprietary roofing SIP made by the Elite Aluminum Corporation of Ft. Lauderdale, FL.

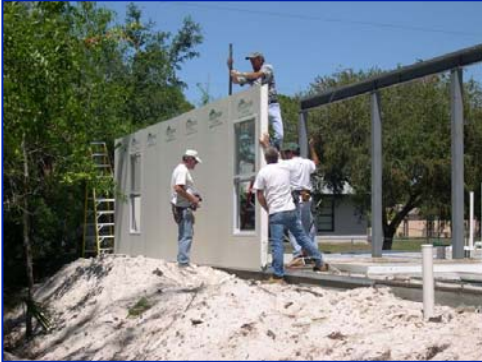
A four man crew can quickly and easily install the Home Front, Inc. SIP walls.

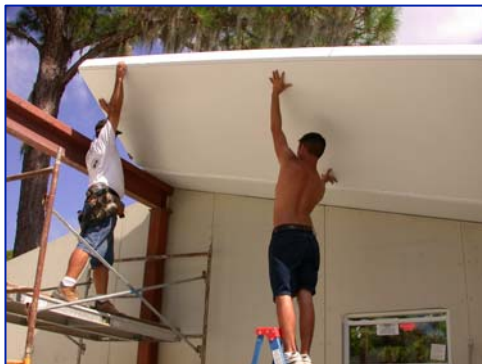
SIPs can also be installed as roofing or flooring systems.

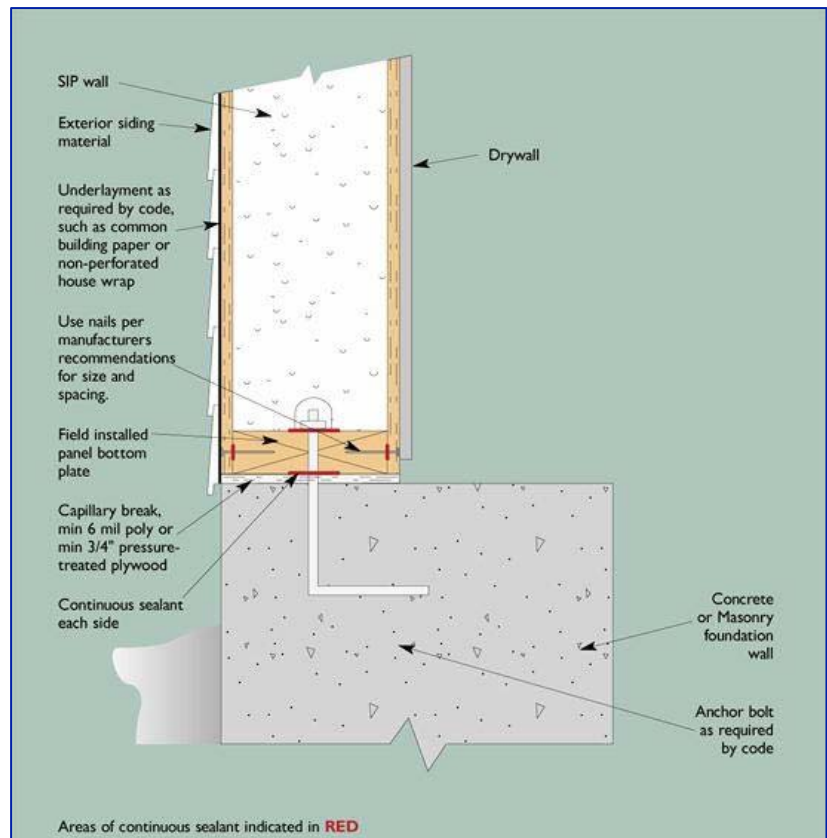
Cross section detail of a typical SIP and the wall to foundation connection.
